HeatShield® Cerfractory Foam

Restores the Integrity of Your Fireplace

HeatShield Restores the Integrity of Your Fireplace Smoke Chamber

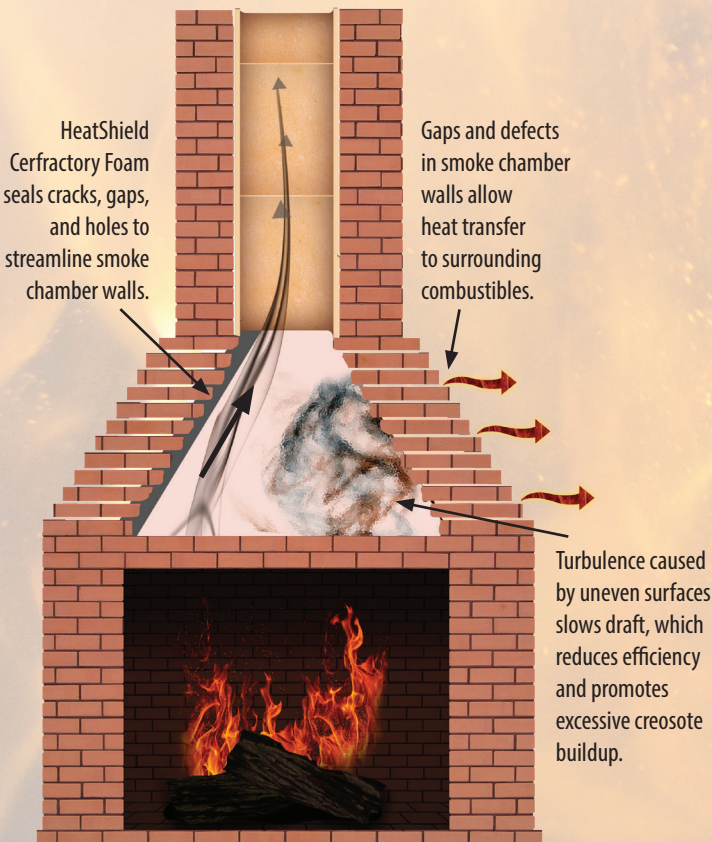
Smoke Chamber or Fire Chamber

In your masonry fireplace there is an area called the smoke chamber, which can usually be viewed by shining a strong light up through the damper. Its function is to safely transition smoke and hot gases from your fireplace to the narrow flue of your chimney. Roughly the shape of an upside down funnel, the smoke chamber starts just above the damper and ends where the chimney begins. The bricks along the sides of the smoke chamber are often stepped outward, one above the other, until they meet the flue. This is a process called "corbeling." The corbeled brick in your smoke chamber will look like an upside down staircase. A fireplace's efficiency and integrity depend on an unobstructed, smooth surface; therefore, the corbeled areas of the smoke chamber should be coated with an insulating, high-temperature mortar to fill any gaps and smooth out any jagged edges.

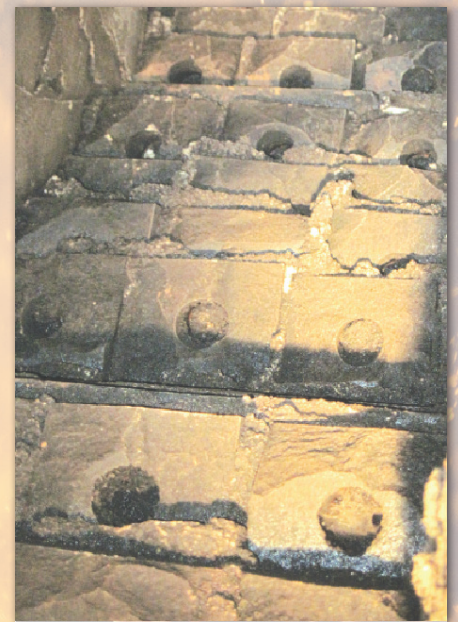
Jagged corbeling and exposed brick cores (holes) in smoke chamber

According to the National Fire Protection Association (NFPA), defective smoke chambers are the third leading cause of chimney related house fires. For the safety and efficiency of your fireplace, it is important that any gaps, cracks, or holes in the smoke chamber be sealed and the brick corbeling be made smooth. Because the smoke chamber is a "high heat" area, any gaps, cracks, or holes can allow excessive heat to attack any surrounding wood or combustibles. The jagged corbeling slows the draft and will provide more surface area for highly combustible creosote to form.

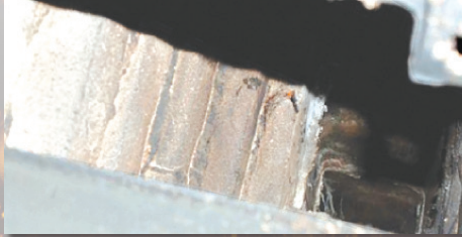
Exposed brick corbels before HeatShield Cerfractory Foam

HeatShield Cerfractory Foam Smoke Chamber Sealant is a high-temperature, expandable foam. It's applied using a specially designed sprayer to coat the walls of your smoke chamber, restoring the integrity of your fireplace. It seals gaps and cracks, as well as smooths up any jagged and corbeled brick edges.

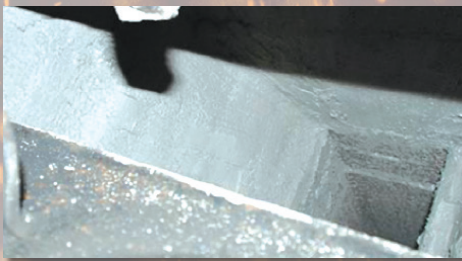
Streamlined smoke chamber wall after HeatShield Cerfractory Foam
